Report of Survey of the M/V Boat Name

2007 Four Winns 358 Vista

July XX, 20XX

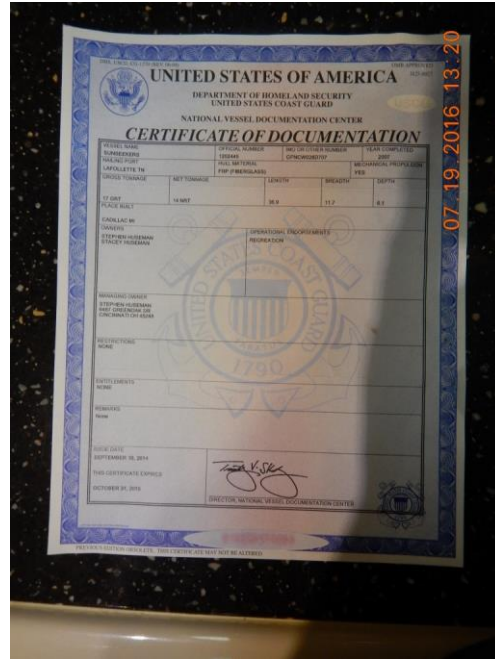
Figure 2 - Certificate of Documentation (Expired)

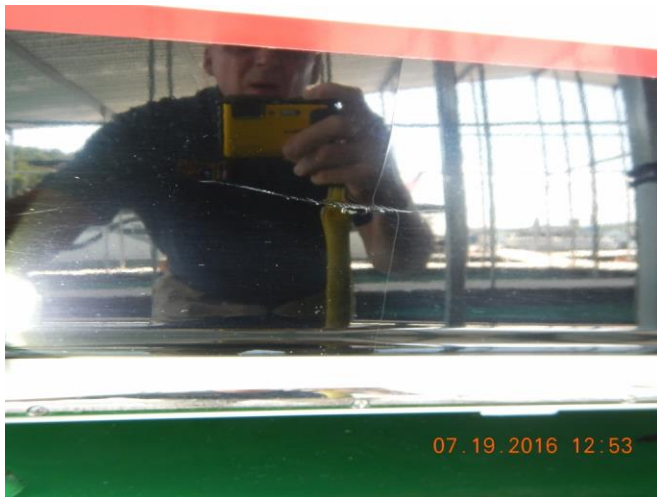
The decks of the vessel are in very good condition with no indication of damage or defect with the exception of the port side gunwhale beginning about six feet from the stem. The FRP gunwhale at that location appears to have been cracked due to compression with associated ripples extending forward along the gunwhale about six feet. The main or heaviest damage is directly above the 'Sling Here' placard on the port side forward.* The sunpad cushions on the foredeck are in good condition with tight threads and snaps that appear to be complete and intact.*

Figure 13 - Damage to Gunwhale

6. . THE FRP GUNWHALE APPEARS TO HAVE BEEN CRACKED DUE TO COMPRESSION WITH ASSOCIATED RIPPLES EXTENDING FORWARD ALONG THE GUNWHALE ABOUT SIX FEET. THE MAIN OR HEAVIEST DAMAGE IS DIRECTLY ABOVE THE 'SLING HERE' PLACARD ON THE PORT SIDE FORWARD. – *OBTAIN ESTIMATES OF REPAIR FROM SEVERAL REPUTABLE FRP REPAIR SHOPS, AND REPAIR AS SOON AS POSSIBLE.*
7. AIR CONDITIONING SHORE POWER RECEPTACLE SHOWS SIGNS OF EXCESSIVE HEAT. BOAT SIDE OF SHORE POWER CABLE ON SAME CIRCUIT ALSO EXHIBITS SIGNS OF EXCESSIVE HEAT. – *REPLACE CONNECTORS ON BOAT AND ON CORD TO REMOVE BURNED COMPONENTS.*
8. THE RAW WATER INTAKE FOR THE GENERATOR IS ONLY SINGLE CLAMPED AT THE SEACOCK. AS A BELOW THE WATERLINE THRU-HULL, THIS INTAKE SHOULD BE DOUBLE CLAMPED IF THE LENGTH OF THE TAILPIECE ALLOWS. – *INSTALL SECOND CLAMP IF SPACE ALLOWS.*

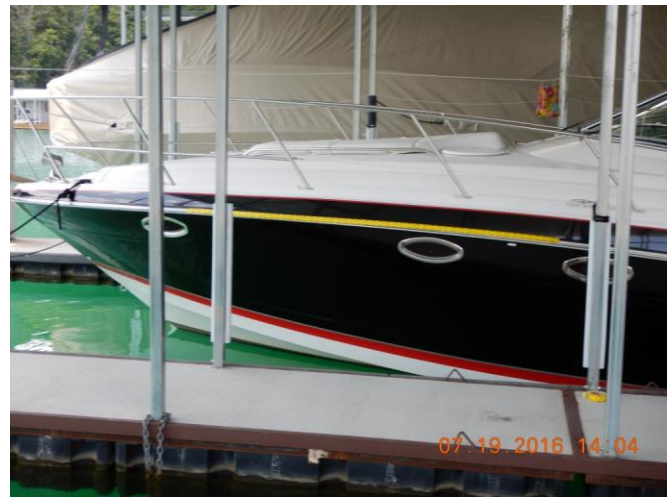
Figure 14 - Span of Damage to Gunwhale (Yellow Tape)

The subject vessel has been well maintained and is in excellent condition with the exception of the damage to the gunwhale. Were it not for this, the vessel's condition and value would have been rated at ABOVE AVERAGE. To take into account the loss of value in the boat due to the damaged gunwhale a deduction of \$3,000 is taken as an estimated loss of value.

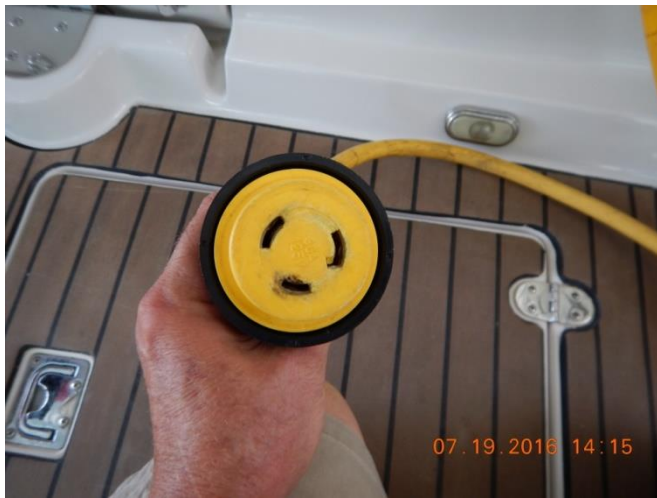
The shore power system for the vessel is fed from two 120 volt / 30 amp inlets which connect to the vessel via connectors in a locker on the starboard side of the swim platform. The upper boat side connector is in good condition while the lower connector (used for the Air Conditioning System) exhibits indications of excessive heat most likely caused by age and a resistive connection.* The shore power cables themselves are in serviceable condition, although the older looking cable which is in use on the Air Conditioning Circuit will also require a new connector at the boat side due to the previously mentioned excessive heat.*

Figure 27 - Air Cond Shore Power Cable connector excessive heat damage

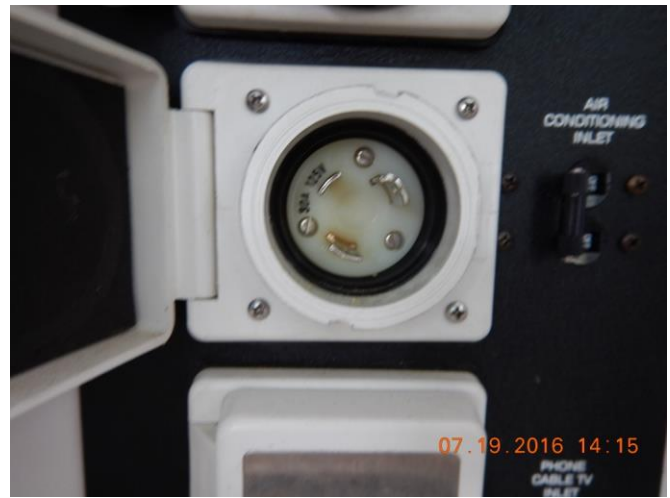
Figure 28 - Air Cond Shore Power Inlet connector excessive heat damage

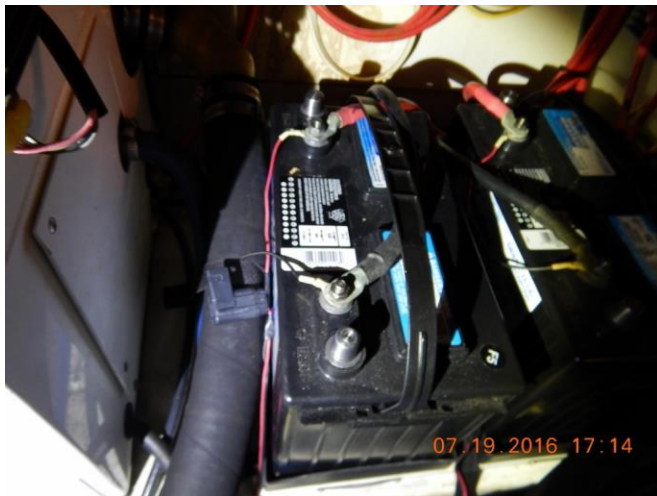
The DC systems of the vessel are built around a three bank battery system; Port Engine, Starboard Engine and House (Ship Systems) Battery. Both engine batteries are size 27 lead-acid batteries located portside in the engine compartment. The House battery is a size 31 Absorbed Glass Mat (AGM) type battery located to port in the engine compartment but inboard of the engine batteries. According to the owner, all three batteries were replaced in 2015. The batteries appear to be in good condition, but all three were improperly installed. Federal regulations require that all batteries be installed in acid resistant containers, secured against unwanted movement up to 100 lbs force in any direction and with the ungrounded terminal (+) protected.*

Figure 30 - Port Engine battery

17. THE ENGINE BATTERY CONNECTIONS ARE IMPROPERLY MADE. SOME OF THE CONNECTIONS ARE MADE WITH THE SMALLER LUGS ON THE BOTTOM OR CLOSEST TO THE BATTERY. IT IS RECOMMENDED THAT THE HEAVIEST AND LARGEST CONNECTIONS BE PLACED CLOSEST TO THE BATTERY. SMALLER CONNECTIONS (LUGS) SHOULD BE PLACED AT THE TOP BECAUSE THEY HAVE LESS CONNECTING SURFACE THEREFORE CAUSING MORE RESISTANCE AND HIGHER CURRENT DRAW. – *CORRECT BATTERY CONNECTIONS TO INSURE MAXIMUM METAL TO METAL CONTACT AREA.*

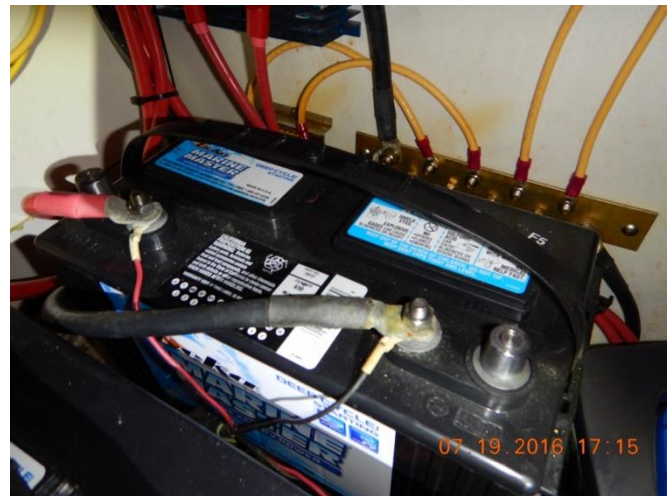
Figure 31 - Starboard Engine battery

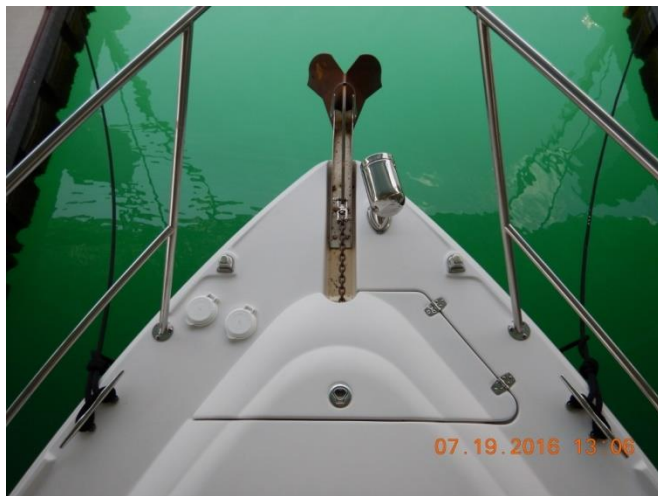
Ground tackle on Boat Name consists of a 15 Lb (estimated) Delta style anchor that appears to be in good condition. The anchor rode consists of approximately 10' of G4 Chain and approximately 50' of braided line. No residual water was noted inside the chain locker. The anchor clevis is not seized or safety wired.*

Figure 34 - Delta Anchor at bow

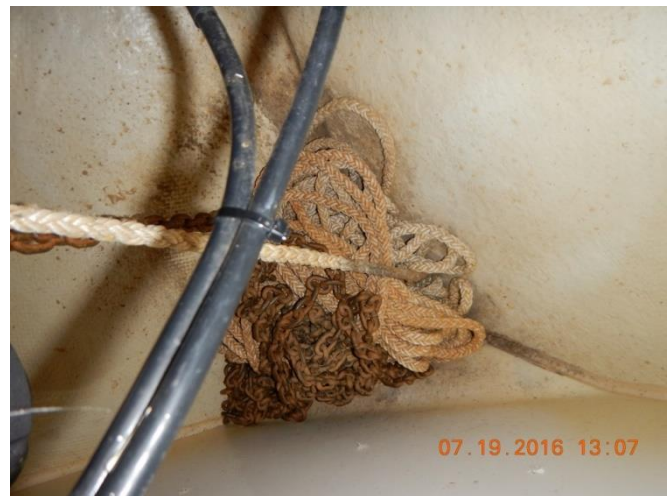
Figure 35 - Anchor Rode
