Report of Survey of the M/V Boat Name

2007 Four Winns 358 Vista

July XX, 20XX

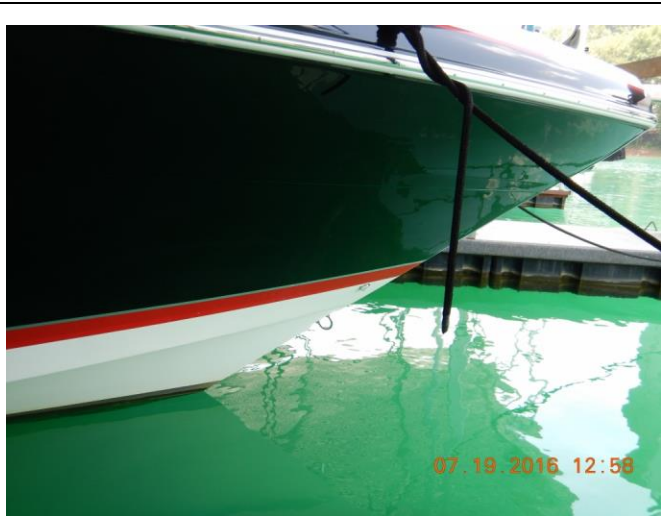
Six acrylic portals are located on the topsides and provide light and ventilation to the vessel’s interior. All portholes appear to be in very good condition with no sign of age or sealant breakdown. A stainless steel rub rail encircles the vessel and is anchored with stainless steel screws approximately 6” apart. The rub rail appears to be in like new condition with no sign of impact or other damage.

Figure 9 - Topsides

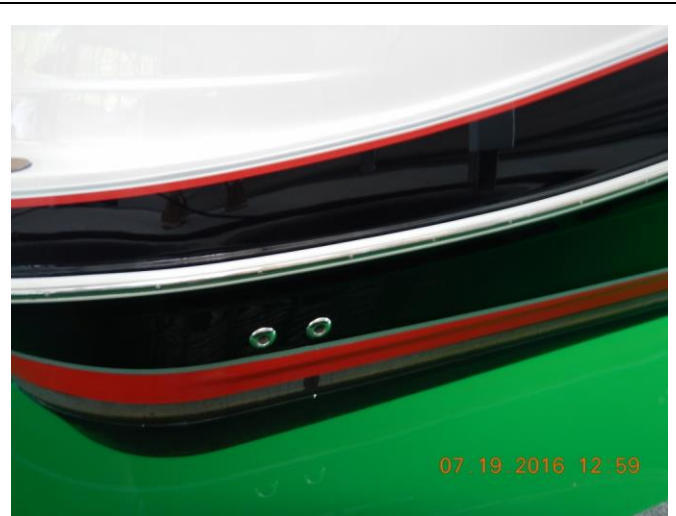
The Thru-Hulls appeared to be in very good condition with no signs of UV deterioration.

Figure 10 - Thru-Hulls and Striping

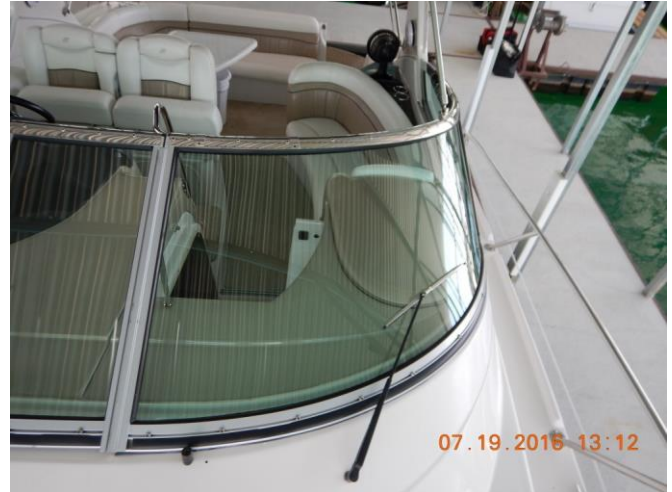
Figure 12 - Windshield

The windshield and side windows are in good condition and display proper alignment. The walk-thru hatch opens and closes without difficulty and the rubber seals appear to be in good condition. The windshield wipers (both sides) operate normally.

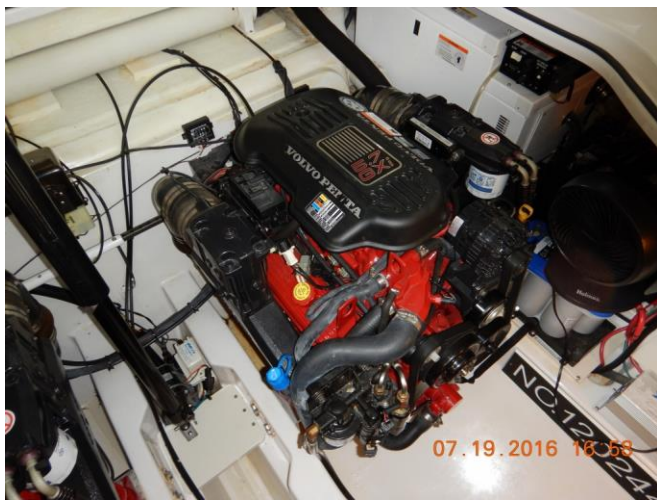
Figure 25 - Port Engine

The engines appeared to be in like new condition, with paint, placards, hoses and belts in very good to excellent condition. The engine mounts are of the adjustable type and appeared to be in very good condition. The engine compartment was extremely clean. The engines are controlled via a Volvo-Penta electronic throttle command system. The system operated well during the sea trial but is sensitive and extreme care should be used in learning how to pilot the vessel.

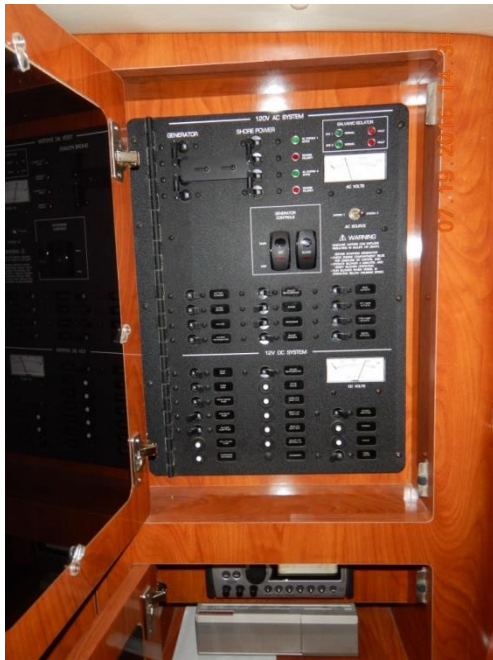
Figure 29 - Main Electrical Panel

The AC Electrical system is monitored and controlled via the Main Electrical Panel in the saloon. The panel is located behind a closeable panel door in the port bulkhead at the base of the companionway. The panel is equipped with an analog voltage indicator, reverse polarity indicators, Galvanic Isolator status lights. AC source selection is accomplished
